Technical Service Bulletin

94 Exterior lights have moisture accumulation

94 21 34 2012749/15 February 17, 2021. Supersedes Technical Service Bulletin Group 94 number 19-18 dated December 6, 2019 for reasons listed below.

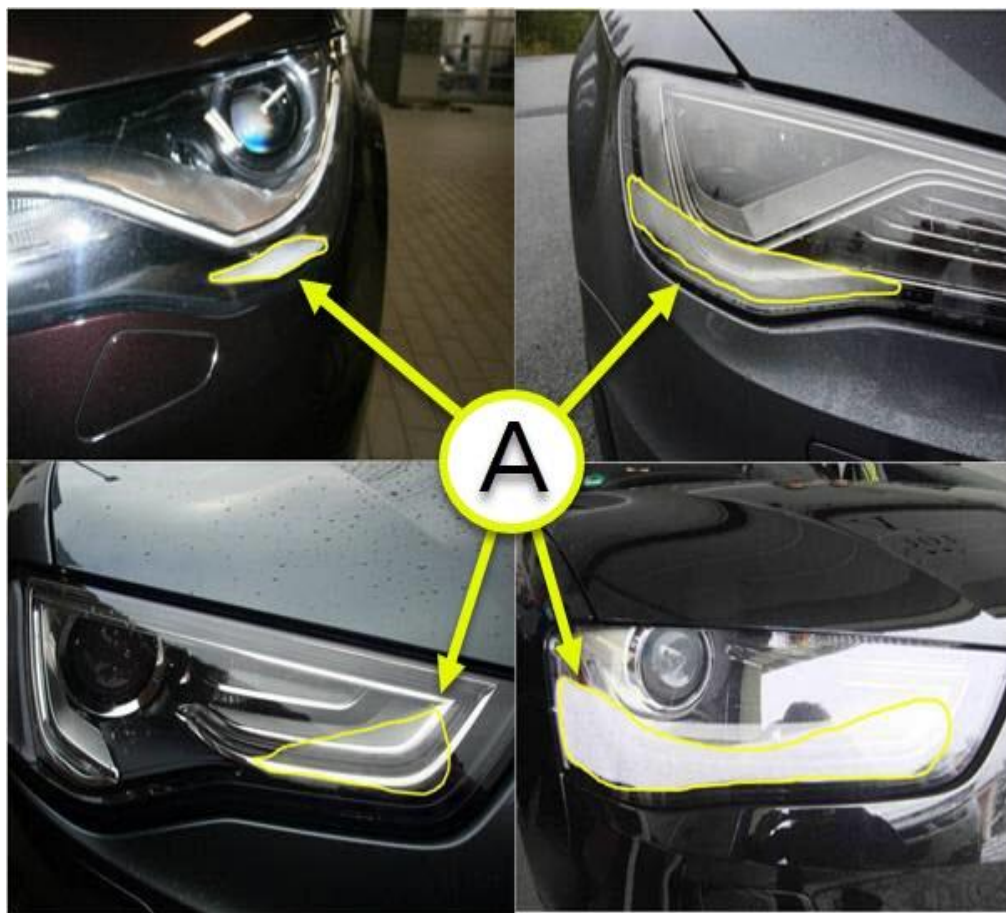
- Condensation is visible on the inside of the headlight, taillight, fog light, side marker light, front turn signal, daytime running lights, and/or third brake light lens (Figure 1).

Figure 1. Condensation on the inside of the lights.

The headlight ventilation system allows air from the exterior of the assembly to pass through the headlights. This open water-protected ventilation system (which is needed for pressure compensation) creates different climate zones in the headlight: very warm areas, where the lens is warmed up by the light, and relatively cool areas, where the lens is cooled down by the airflow.

Considerable differences in humidity and temperature between the inside and the outside of the headlights, even when the car is being driven, can create condensation. While condensation is most common in cold and wet weather, it can also occur after a car wash, or when the temperature changes. Condensation is more visible on lenses made of clear glass than on lenses with patterns. The moisture does not affect the headlight function or light performance, and it does not lead to corrosion or damage to other headlight parts.

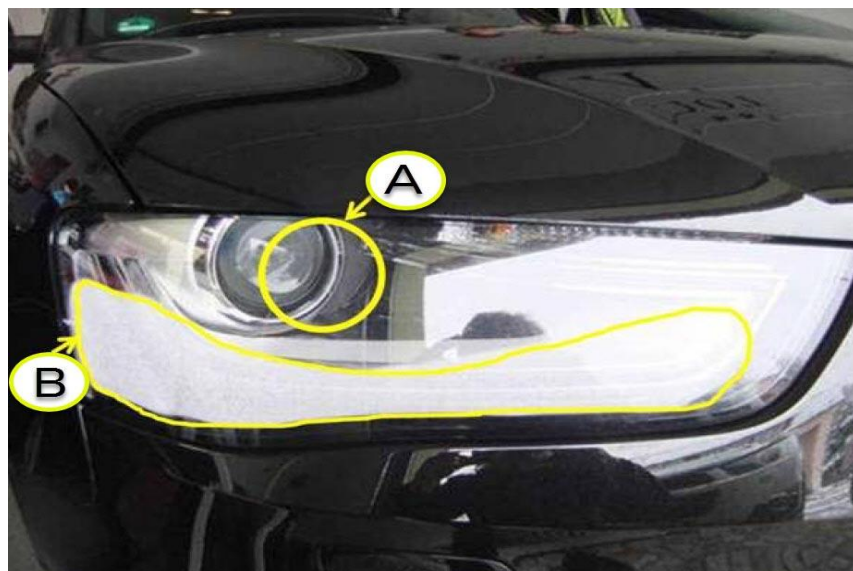
1. The light emission surface (Figure 2A) of the main beam should be clear after driving 10 minutes with the main beam on.
 - Driving speeds must be consistently over 45mph for the ventilation system to properly function.
 - Residual condensation (Figure 2B) may be present depending on ambient conditions, this is normal.

Figure 2. A: Main beam light emission surface. B: Condensation of the headlamp.

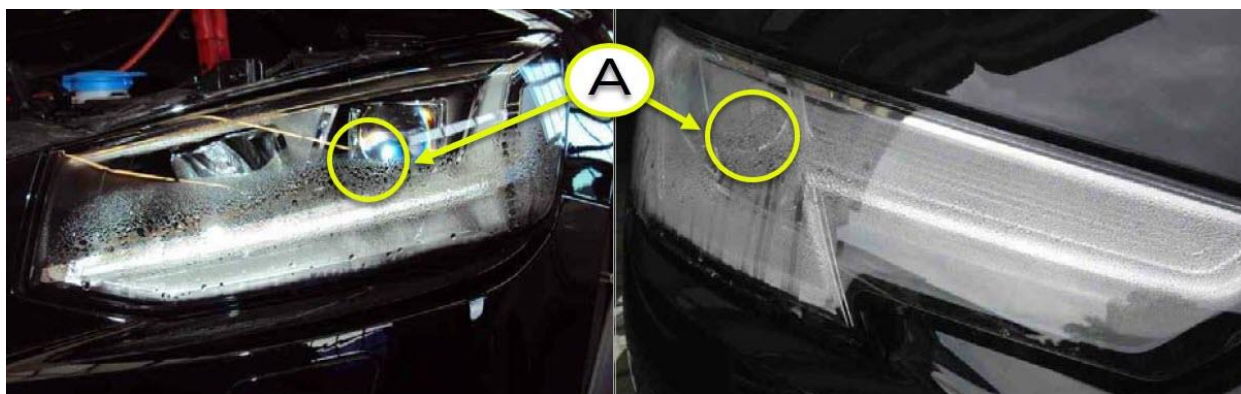
2. If water drops or condensation are present on the light emission surface (Figure 3A) after performing step one, inspect the headlamp assembly for the root cause:

- Missing cover.
- Damaged seal.
- Clogged drain.
- Outside influence.

Figure 3. A: Main beam light emission surface.

- In cases where the headlamp assembly is not the root cause (clogged drain and/or missing access cover), dry the headlamp assembly with compressed air.
- Perform a visual inspection of electrical connectors and any control modules attached to the headlight. If corrosion is found in one of these components, it must be repaired or replaced. Reference the repair manual for repair instructions.
